MICROWAVE PATH SURVEY REPORT

RADIO FREQUENCY INTERFERENCE (RFI) MEASUREMENT REPORT

ViaSat

Transmit and Receive Earth Station
17-21 GHz and 27-31 GHz

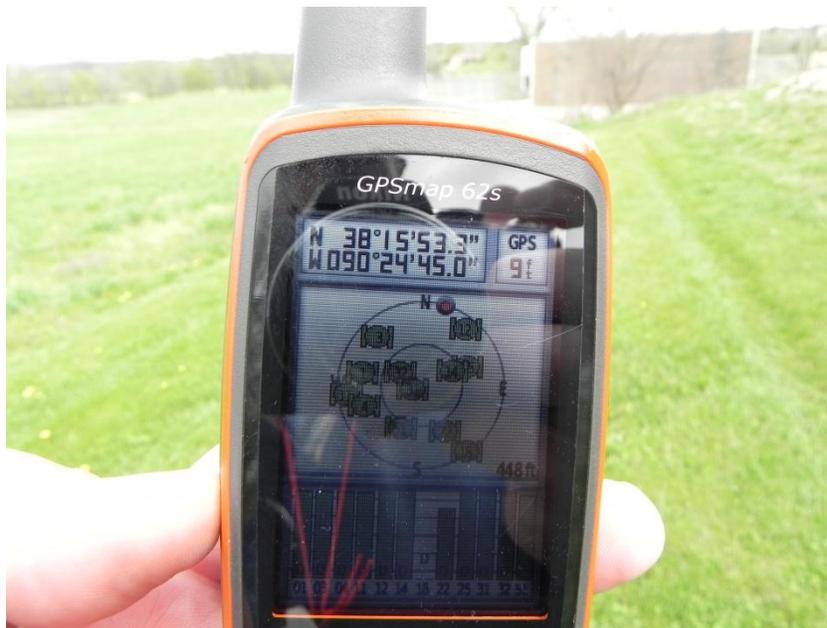
Figure 1.2-3 – GPS Photograph

The measured site is identified on a portion of a topographic map shown in Figure 1.2-1. An aerial photo of the site location is shown in Figure 1.2-2. A photo of the measurement using a GPS is shown in Figure 1.2-3.

Selected Location

Physical Test Location

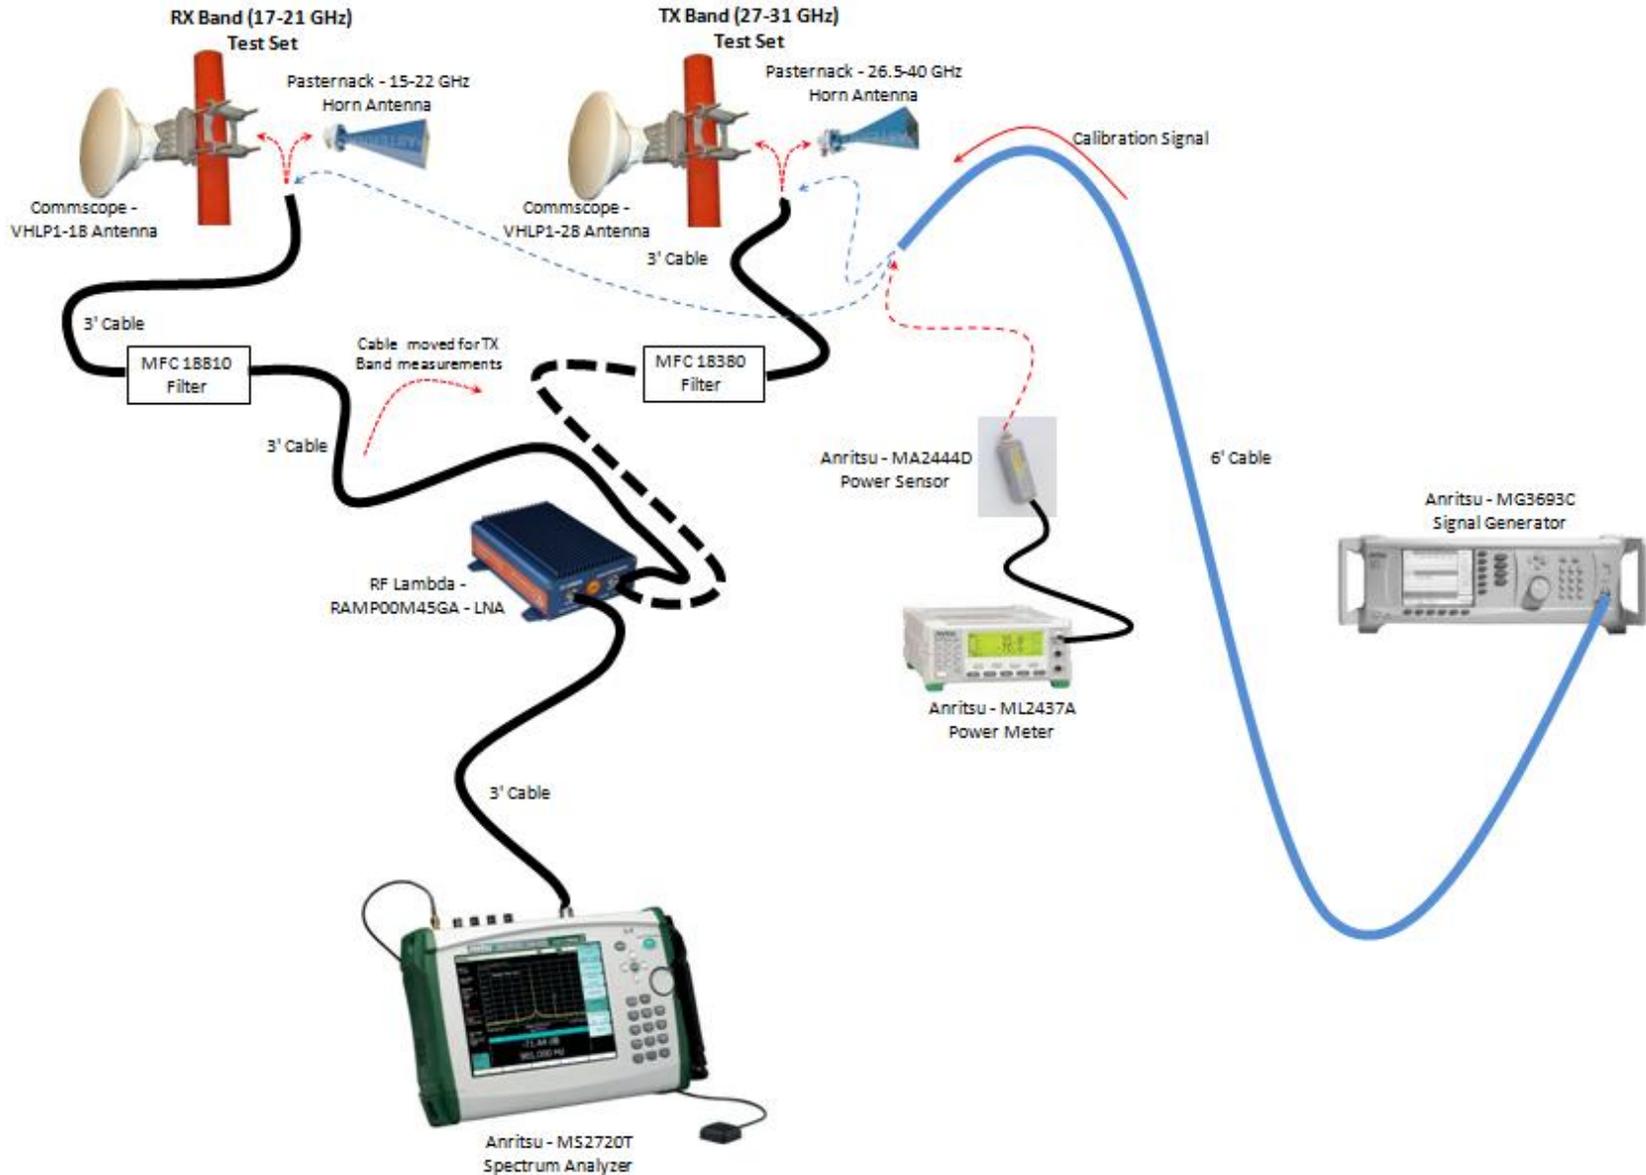
Figure 2.1-1 Receive Test Equipment Block

Figure 2.1-1 is the block diagram of the test set for all bands to be tested. All test equipment used was allowed a proper warm-up period prior to calibration. The test set was calibrated by the signal substitution method, as recommended by NSMA, utilizing a synthesized signal generator. The reference signal from the signal generator was adjusted for the center frequency of each band to be tested and measured with a thermal power meter for calibrated reference test level (-60 dBm). This calibrated reference signal from the signal generator was then injected into the end of the coaxial cable of the test set at the point, which normally connects to the test antenna. A spectrum analyzer then measured the reference test signal level after passing through the test set. At this point, the spectrum analyzer was calibrated such that the top graticule of the spectrum analyzer display (-60 dBm) corresponded to the injected reference signal (-60 dBm) by utilizing the reference level offset function of the Anritsu –M52720T spectrum analyzer. Upon completion of the calibration process, a known reference level was obtained for the measurements that correspond to a given set of spectrum analyzer display readings.

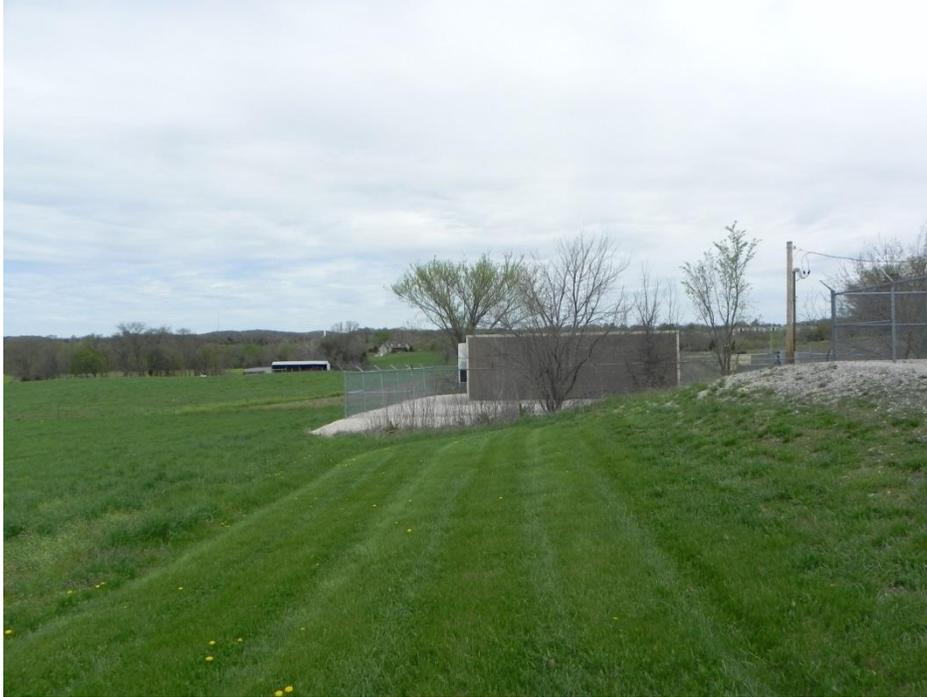
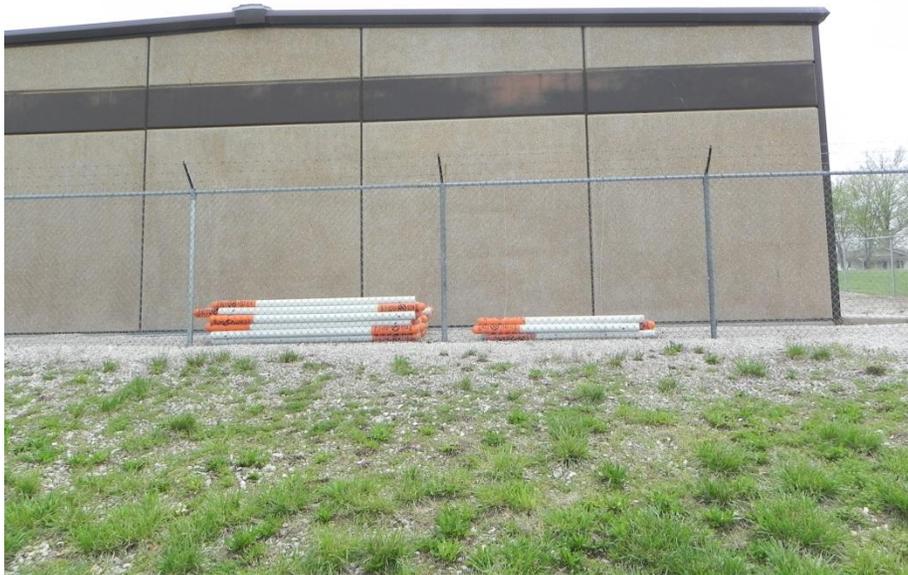
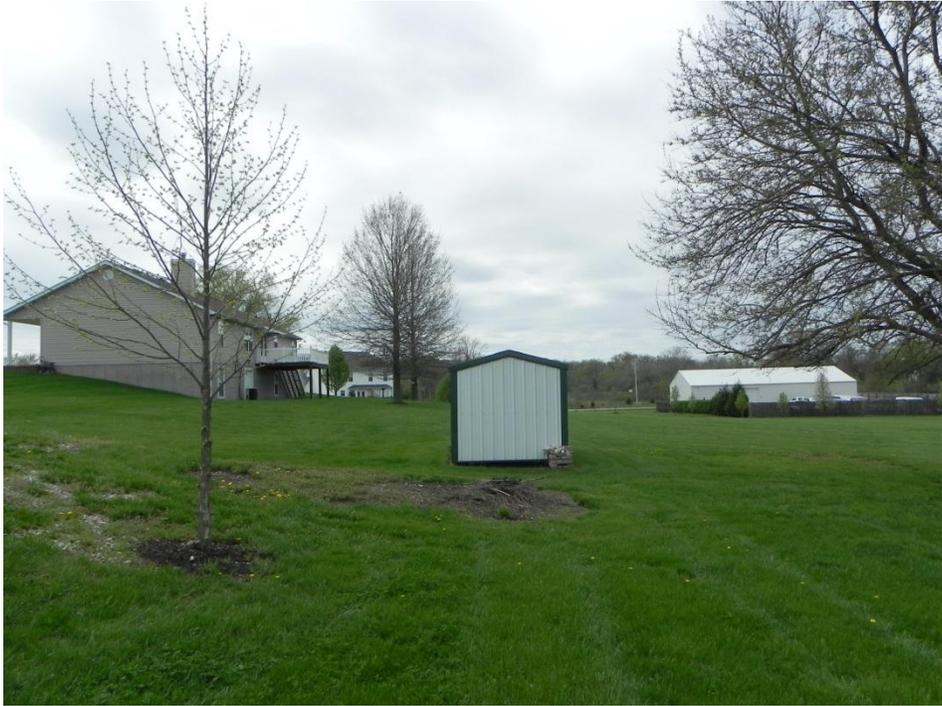
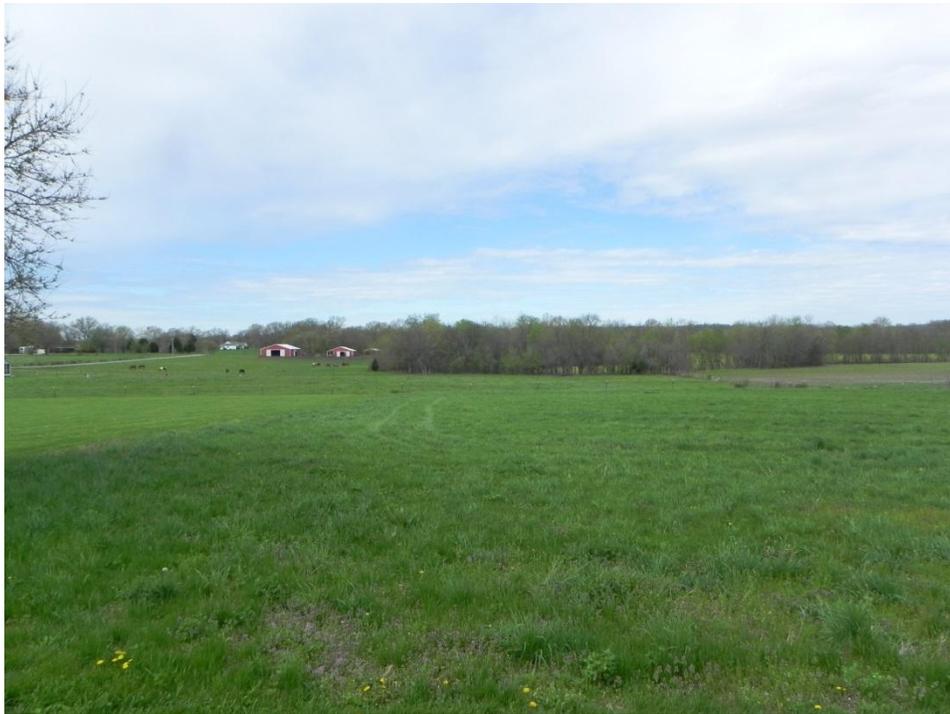
Figure 3.1-1 Earth Station Site Photographs

- Table 3.1-1 presents a site data sheet including all pertinent site information.
- Figures 3.1-1 and 3.1-2 are the photographs depicting the existing earth station site and satellite arc.
- Figures 3.1-3 through 3.1-10 are the RF spectrum photographs depicting the interference environment at the test site.

| 8. GEOSTATIONARY ARC VISIBILITY: | Satellite arc has no blockage at this time |

There is no potential satellite arc blockage at this site. Final arc clearance will depend on antenna placement.

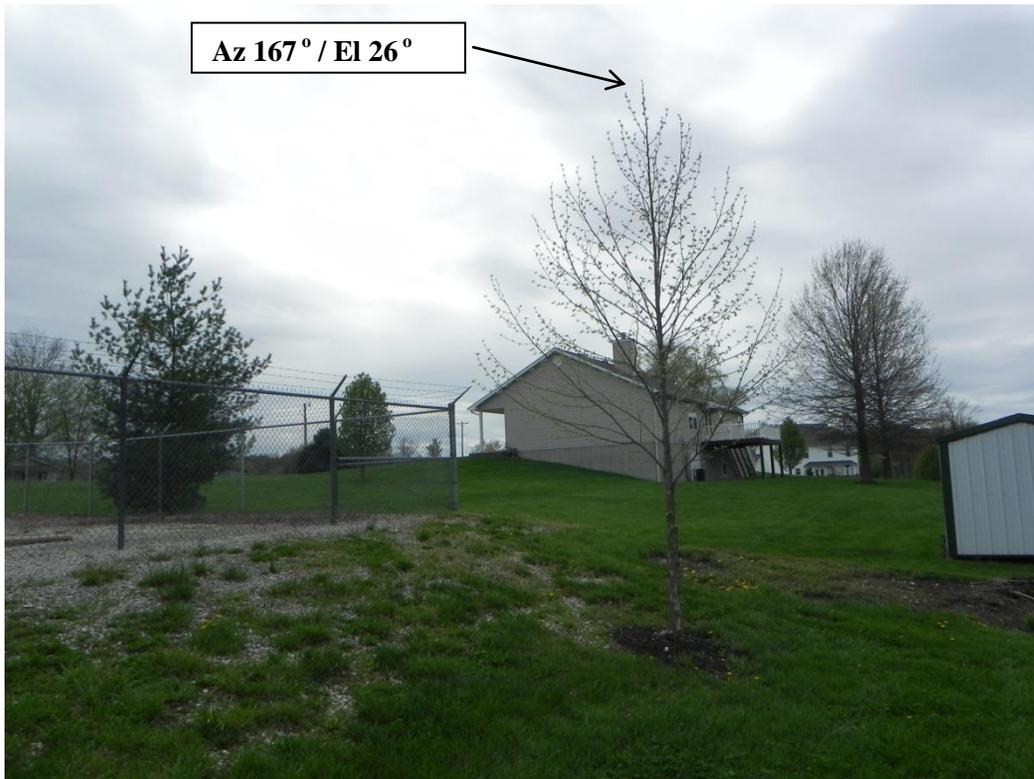
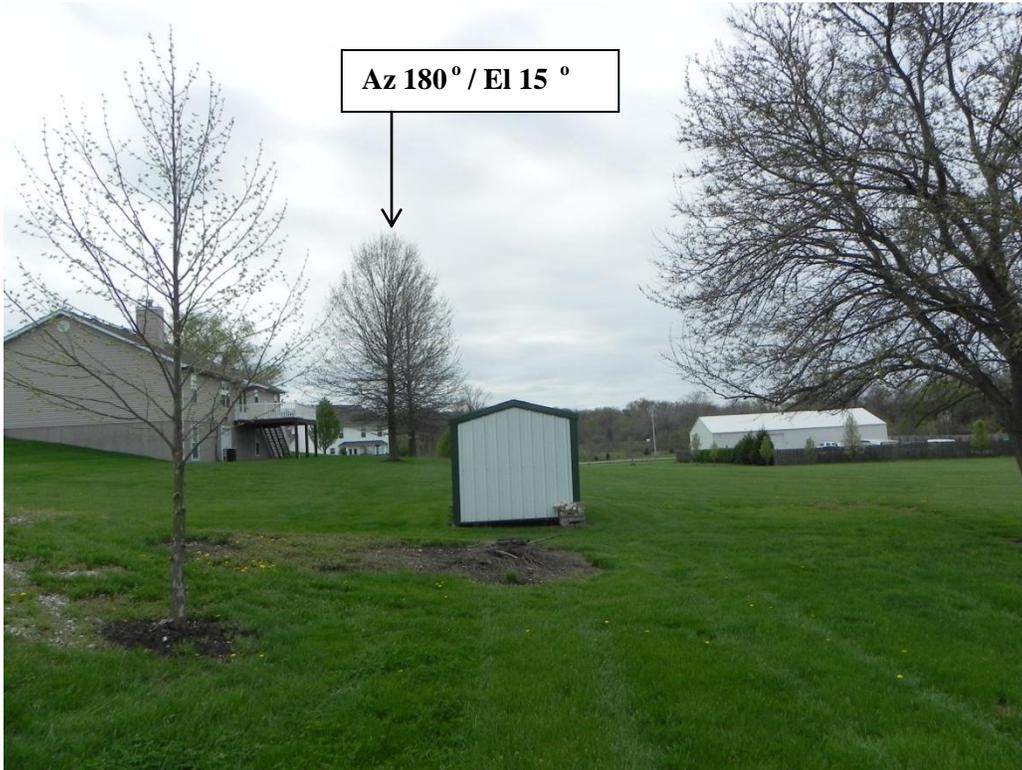
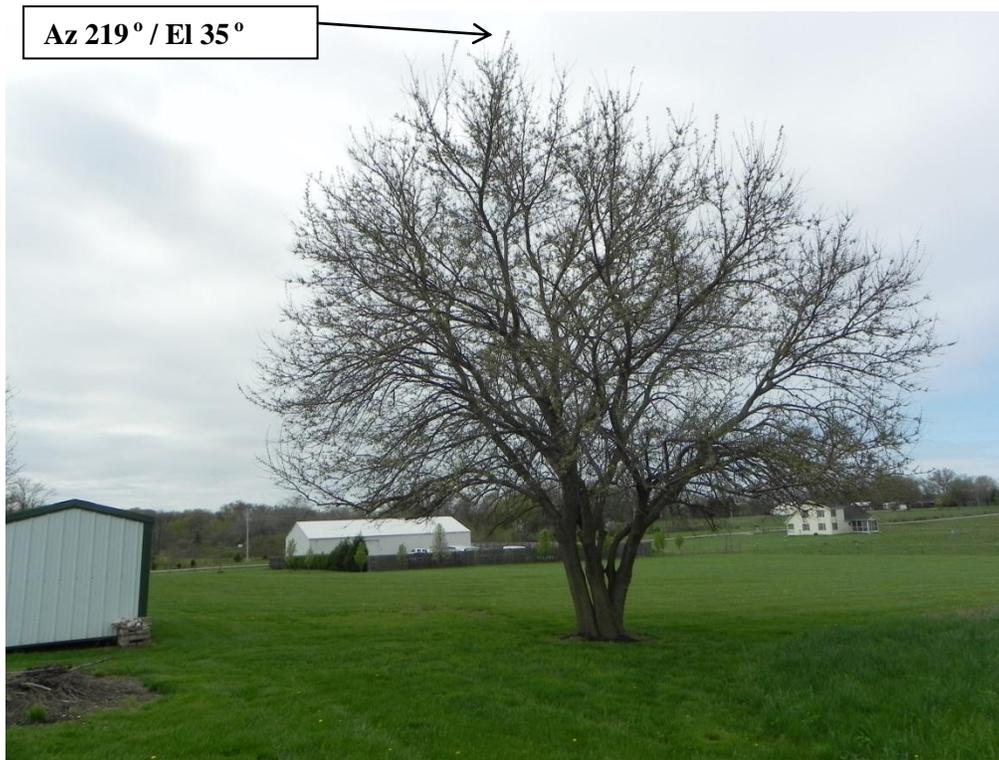
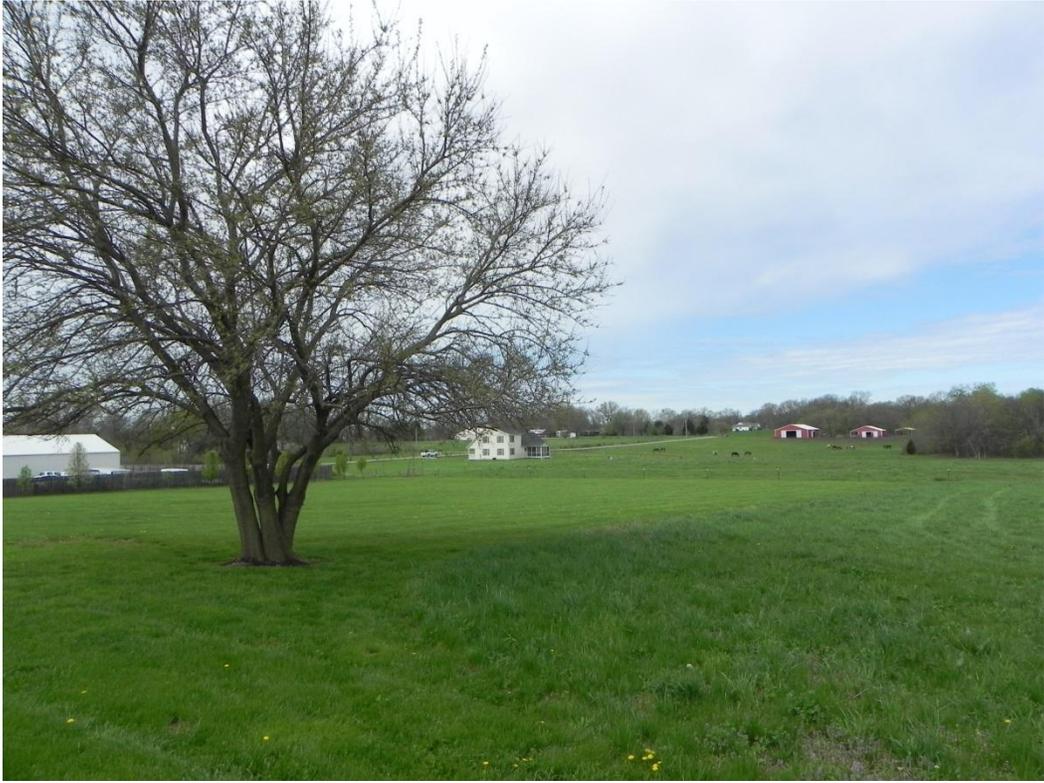
Figure 3.1-2 Horizon Photographs of Earth Station Site

The satellite arc has no potential blockage from 55W through 115W.
